**Good Practice Guide No. 120**

Avoidance of Corrosion in  
Plumbing Systems

# Measurement Good Practice Guide No 120

## Avoidance of Corrosion in Plumbing Systems

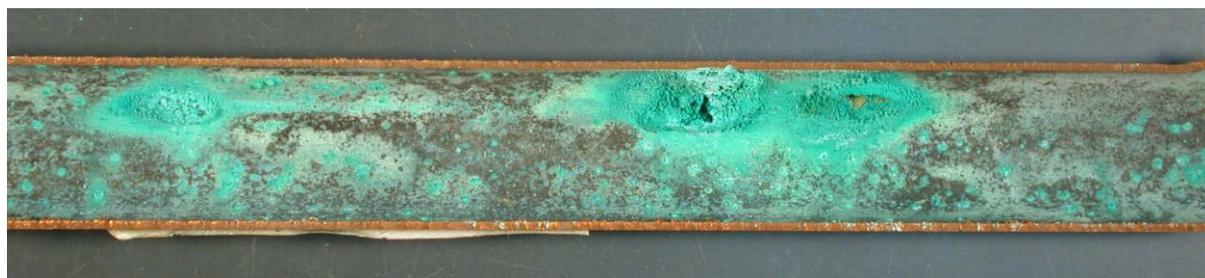
Type 1 pits appear as hemispherical pits overlaid with a mound of blue-green malachite or basic copper carbonate ( $\text{Cu}_2(\text{OH})_2\text{CO}_3$ ). They are usually distributed randomly along a length of pipe, although the deeper pits are nearly always found close to the bottom of horizontal pipe runs. A typical example is shown in Figure 1.

*Figure 1 Type 1 Pitting.*

Although it is not usually practical to change the water composition, the risk of Type 1 pitting occurring can be substantially reduced by always using pipes certified to BS EN 1057 and by avoiding long periods of stagnation between installation and bringing the system into operation. If there is a long period between filling the system and eventual hand-over, then the system should be flushed regularly (at least once a week) in order to introduce fresh aerated water into the system and build-up a stable protective film.

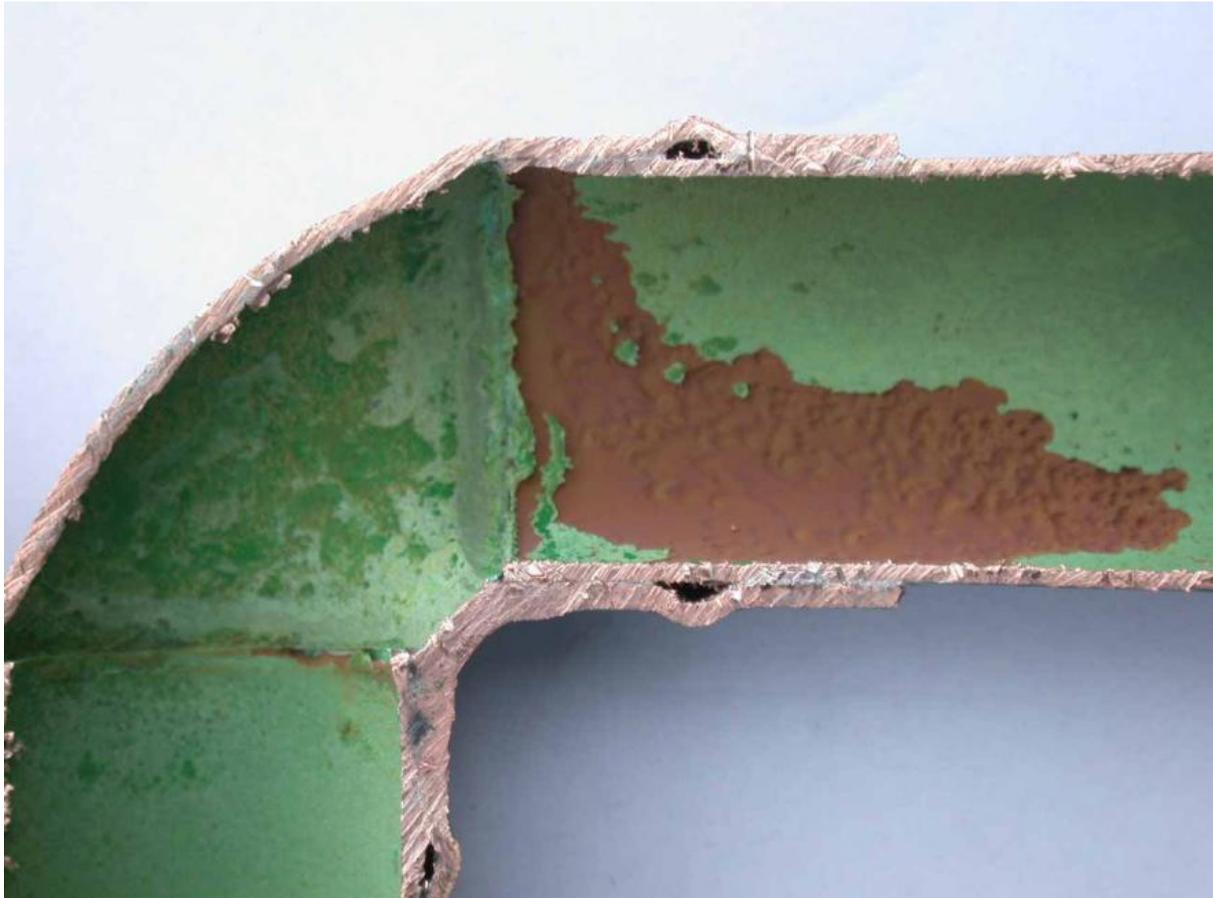
Erosion corrosion occurs due to turbulent flow in copper pipes, which releases air bubbles from the water and which remove the protective patina from the copper surface. Corrosion, which then occurs in these localised regions, takes the form of grooves or horseshoes in the surface (with the 'horse' appearing to have walked upstream). In severe cases, wall perforation can develop within a matter of weeks. A typical example is shown in Figure 4.

*Figure 4 Erosion Corrosion at elbow.*

Erosion corrosion is most often found just downstream of elbows or changes in pipe section, where turbulent flow is more likely. Hot water return lines are prone to this form of corrosion. However, there is a critical flow velocity below which erosion corrosion should not occur. This is often quoted as below 3m/s for cold water pipes and 2 m/s for hot water pipes. However, in soft water or base-exchange softened water, erosion corrosion is possible at flow velocities below these values. Other factors, such as burrs left on cut ends of copper pipes and sharp changes in sections increase the likelihood of erosion corrosion. To prevent the risk of erosion corrosion, flow rates of <2 m/s for cold water and <1.2 m/s for hot water systems should be met. However, in fully softened waters, flow rates should not exceed 1 m/s. Where flows are intermittent, these maximum flow velocities can be relaxed somewhat.

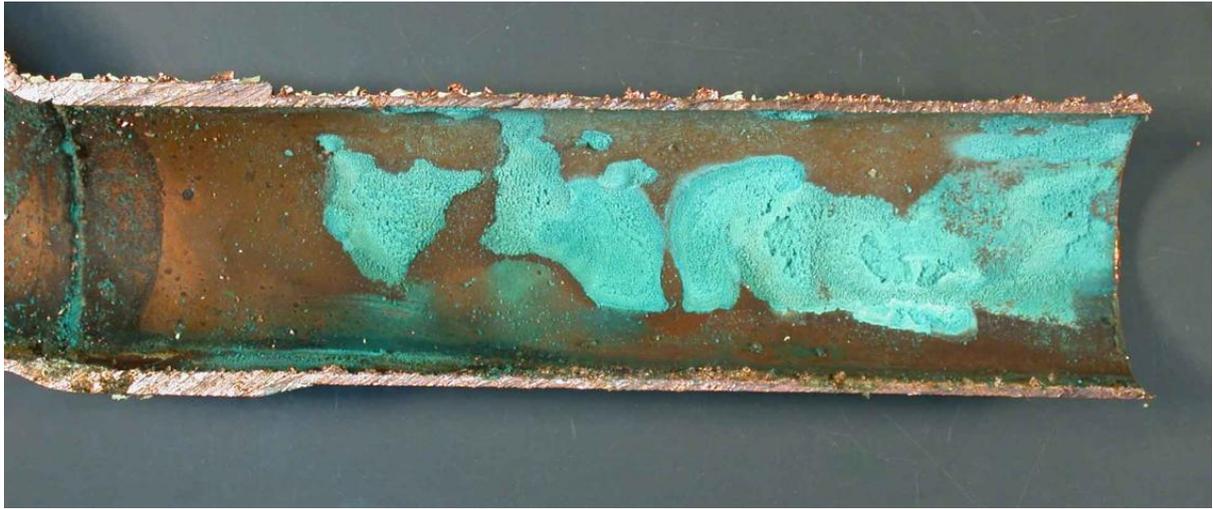
Blue water can occur either due to a high concentration of  $\text{Cu}^{2+}$  ions in the water or, more commonly, through the discharge of particles of copper carbonate patina, which have spalled off the bore of copper pipes. In the first case, this is induced in cuprosolvent water. In the second, it occurs due to a combination of adverse water quality and water stagnation, esp. in the early stages after installation. In either case, it can lead to copper levels in the water exceeding the 2 mg/L limit under drinking water regulations and staining of wash hand basins and baths. Figures 5a and 5b shows an example of an irregular bluish patina which has formed on a length of copper pipe and staining of a wash hand basin.

*Figure 5a Irregular carbonate patina giving rise to blue water.*

In the last few years, there have been several cases of blue water in the north of England, where high levels of phosphate have been found in the copper carbonate patina. The patina itself was irregular and only loosely adherent, so that it was often removed from the top half of the bore. The phosphate derives from the supply water, which has been added by water companies in order to inhibit the corrosion of old lead pipes.

As with pitting corrosion, the likelihood of blue water can be significantly reduced by avoiding water stagnation in the pipes in the period between installation and when the system is brought into use. Chlorination to kill any microbial activity may help as could the fitting of a dolomitic limestone filter on the incoming mains in cases of very soft water. In the few cases where blue water has occurred due to excessive softening, blending the water to give a total hardness of around 60 mg/L, seems to be effective. However, if a substantial irregular patina has been formed then this must be removed by a citric acid flush in order to get back to bare copper. A uniform, stable patina can then only be reformed if regular flushing with fresh water is carried out in the weeks following the citric acid flush. Even then, this treatment may not be effective in the long term, so that complete replacement of pipework may be necessary.

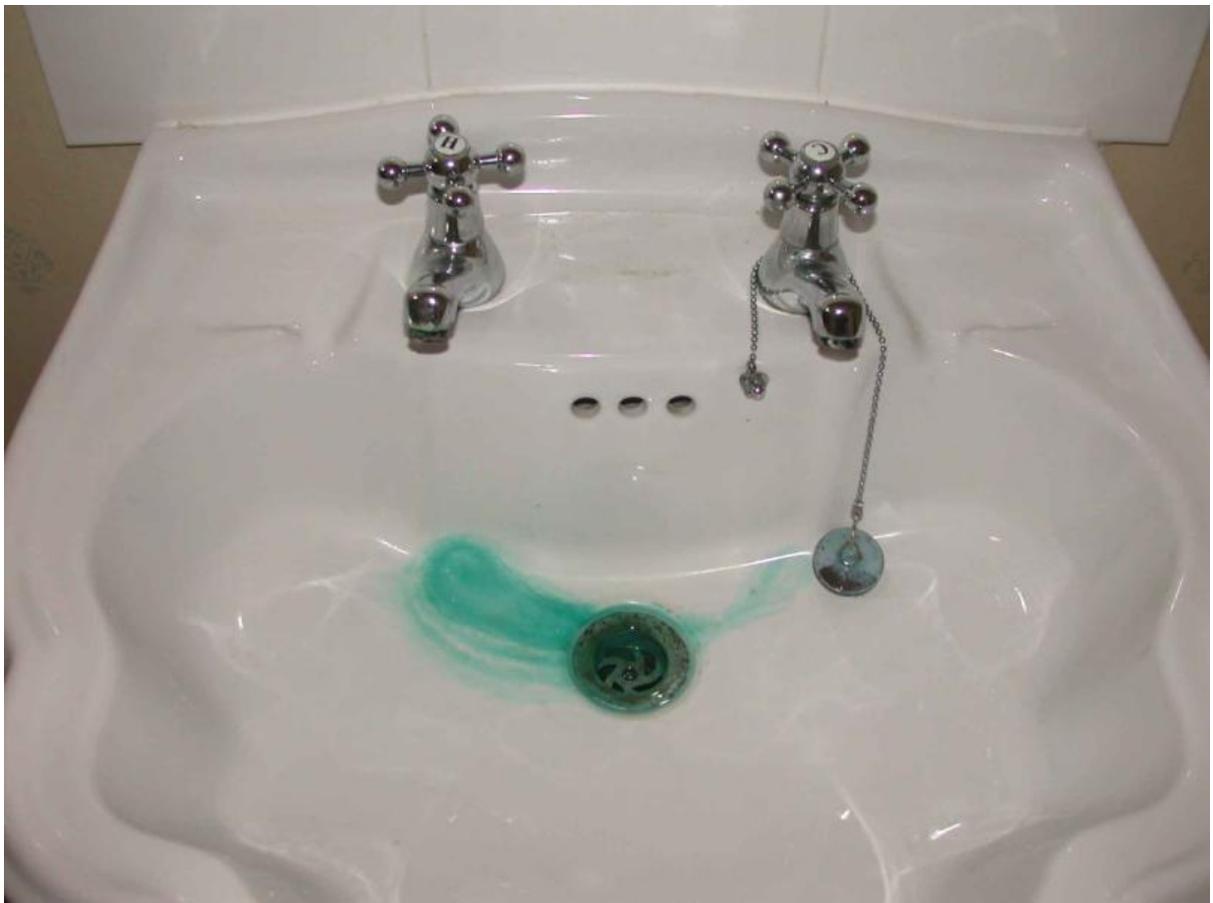
*Figure 5b Staining in hand basin caused by blue water.*

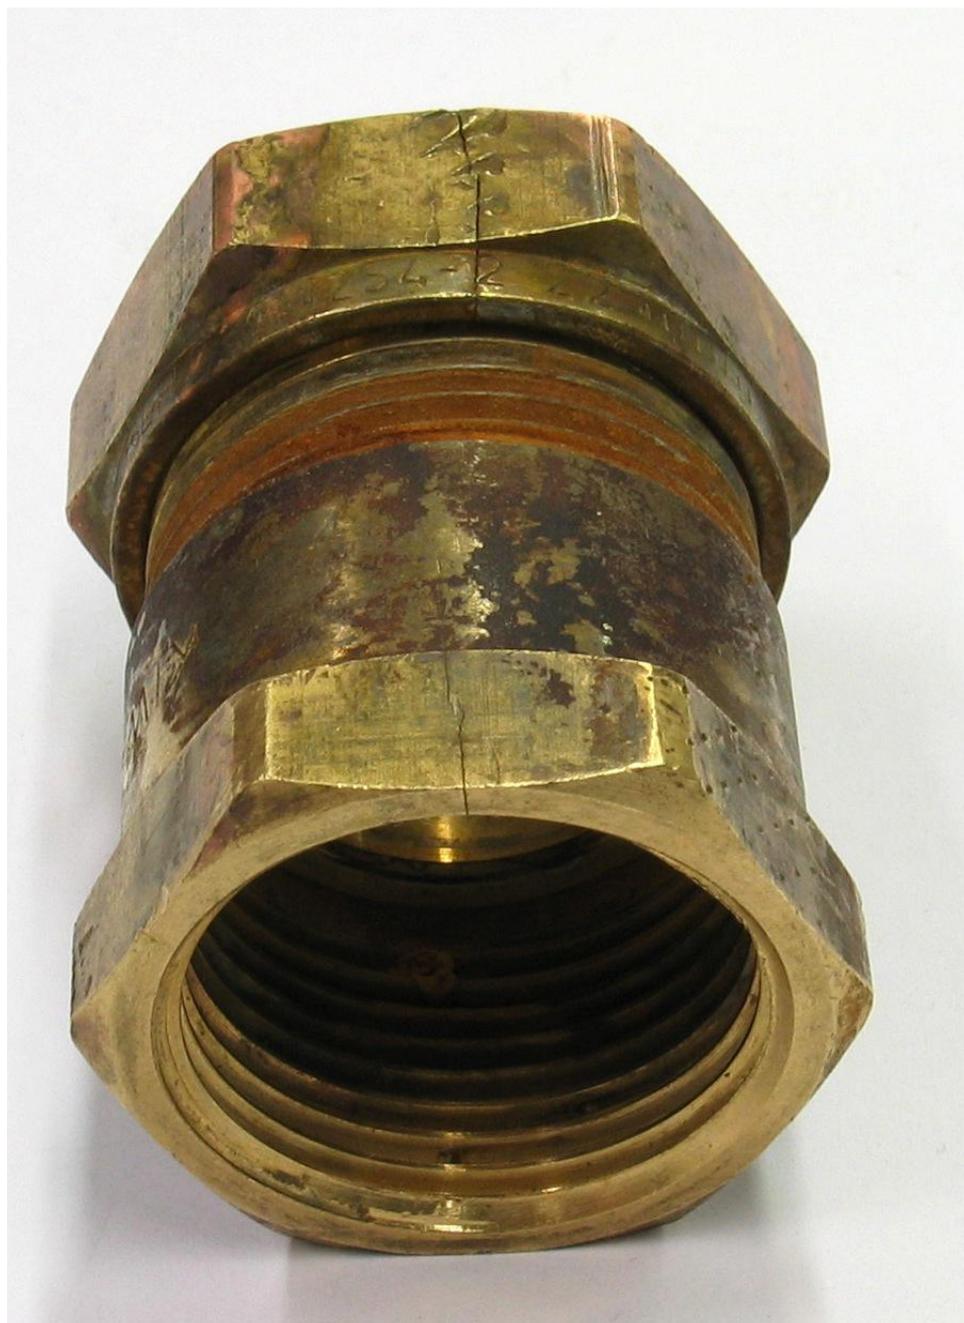
*Figure 7 Stress corrosion cracking in a brass fitting.*

However, SCC of brass fittings in drinking water installations has been found to occur under thermal lagging. For this to happen, water or condensation needs to penetrate under phenolic foam type insulation to the brass surface. In the cases, where this has been found, the fitting has been over-tightened so that there was a high applied tensile stress on one component of the fitting. Figure 7 shows an example of SCC in a brass fitting.

Stress Corrosion Cracking of brass	Presence of moisture and ammonia and high applied tensile stresses on fitting.	If using phenolic foam insulation, prevent condensation on pipe by taping over joints in insulation with Al foil. Do not over-tighten fittings.
